Discussion on “Field Test Performance of Noncontact Ultrasonic Rail Inspection System”

**Discussion of “Field Test Performance of Noncontact Ultrasonic Rail
Inspection System” by Stefano Mariani, Thompson Nguyen, Xuan
Zhu and Francesco Lanza di Scalea.**

Sakdirat Kaewunruen¹

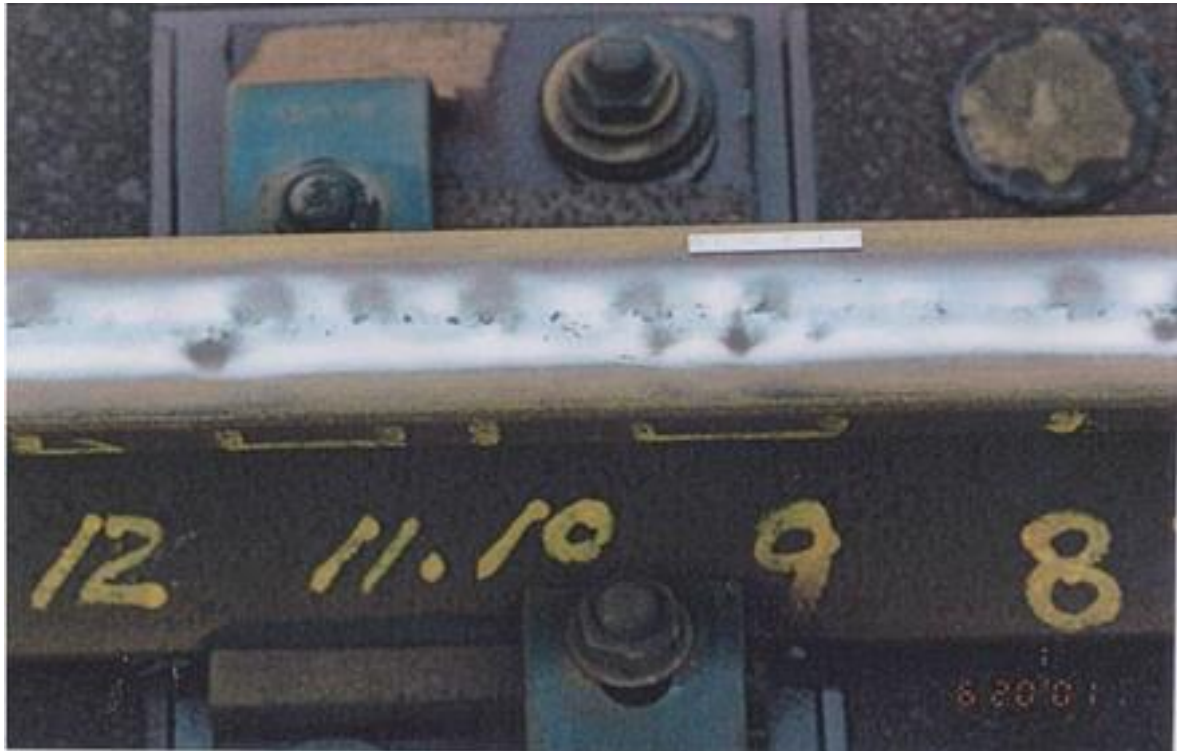
a) WEL-related stud (multiple squats)

Figure 1. Rail squats in railway tracks based on their initiation types (photos taken in 2012 by Sakdirat Kaewunruen)

The field data shown in Figure 1 demonstrates that rail surface defects can potentially spread over the rail head. Note that the field observations showed that rail surface defects can also develop at both low (inner) and high (outer) rails in curved tracks. The dimension and scale of rail defects are again dependent on various factors. If rail corrugations and wheel burns are present, additional vibration might also provide additional problems to the system in practice. As such, suitable device installation and noise cancelling technique will be required to enhance reliability of data analyses such as receiver operating characteristics (ROC), damage index (DI), probability of detection (PD), and probability of false alarms (PFA).
